MISCELLANEOUS PAPER GL-90-7

# CONDITION SURVEY AND PAVER IMPLEMENTATION, EDWARDS AIR FORCE BASE (NORTH BASE), CALIFORNIA

Ross A. Bentsen

Geotechnical Laboratory

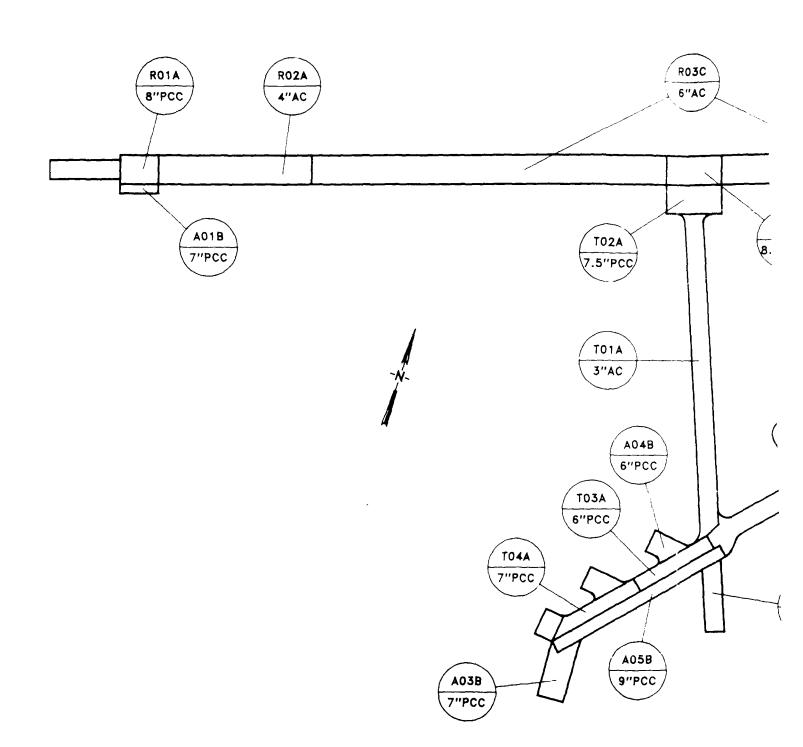
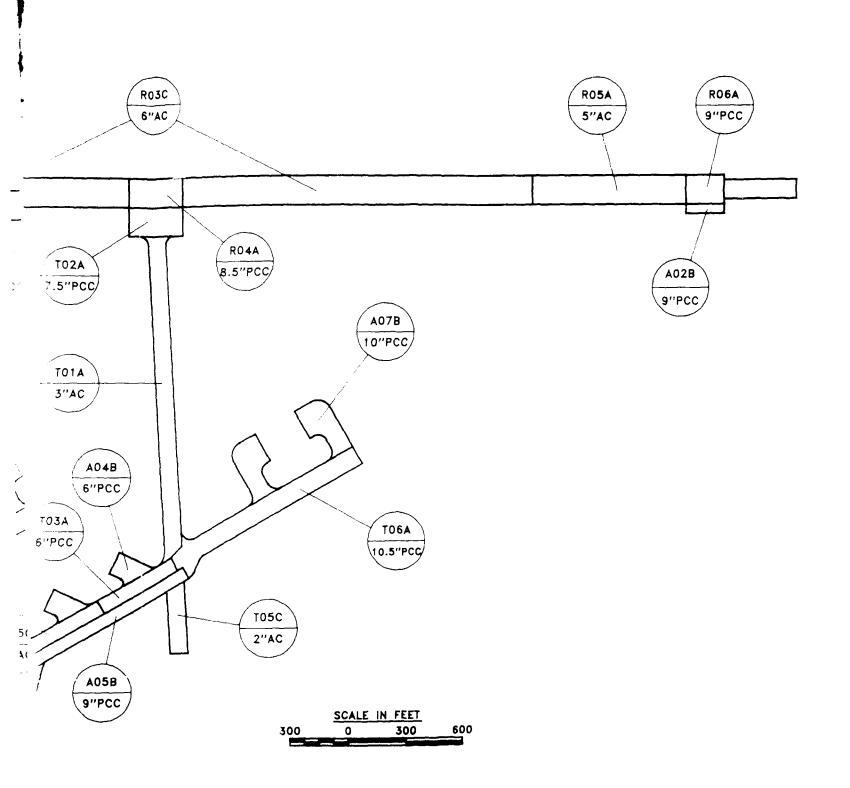
Figure 1. Airfield pavement feature ident

rfield pavement feature identifications of North Base

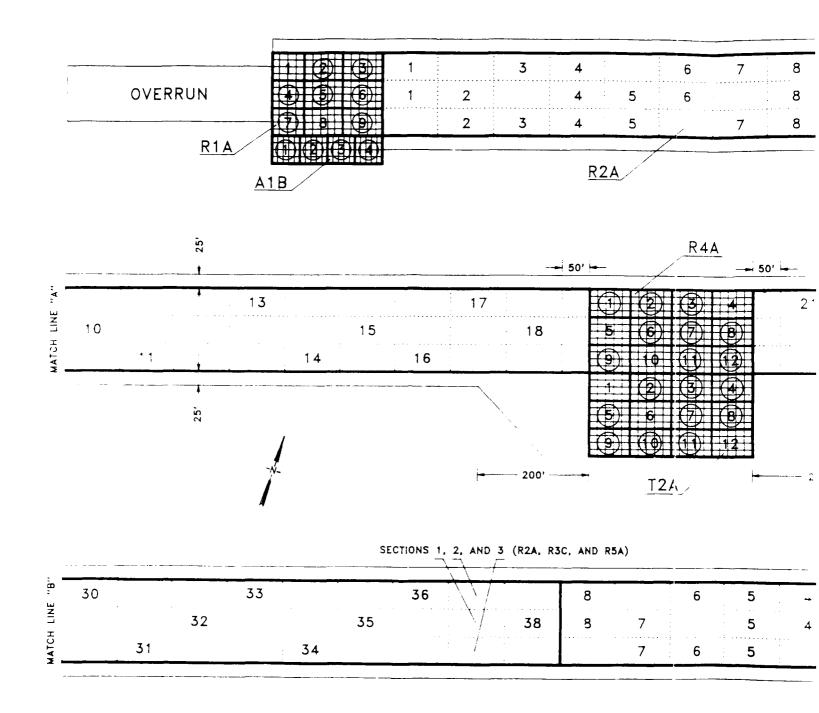
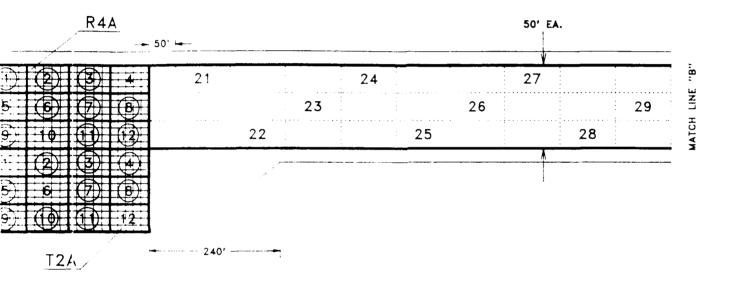
Figure 2. Sample unit layout, Runway 6-24 (features R1A, R2A, R3C, taxiway (feature T2A)

$\sim$  -24 (features R1A, R2A, R3C, R4A, R5A, and R6A) and the main raxiway (feature T2A)

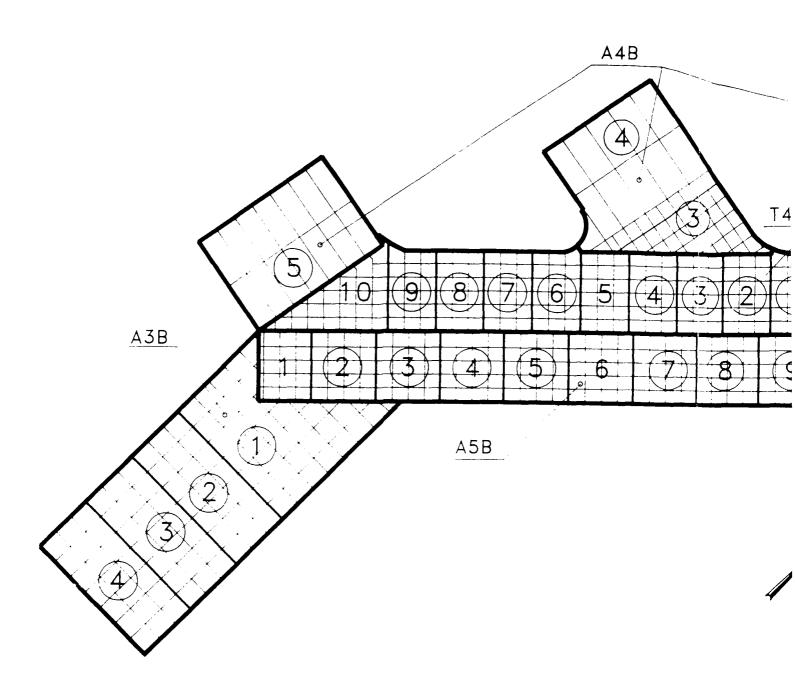
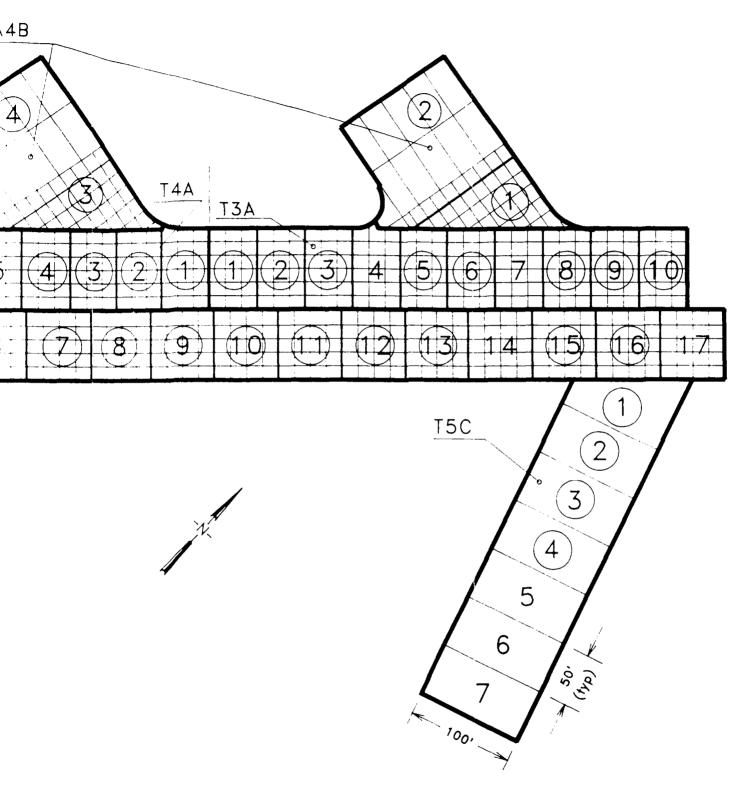
Figure 4. Sample unit layout, the apron access taxiway (features and aprons (features A3B,

access taxiway (features T3A and T4A), the taxiway to lakebed (feature T5C), and aprons (features A3B, A4B and A5B)

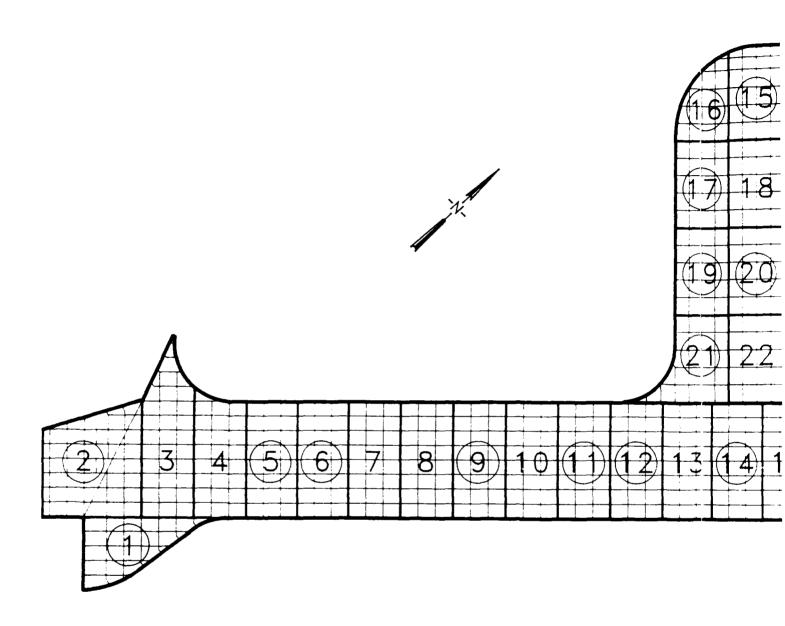
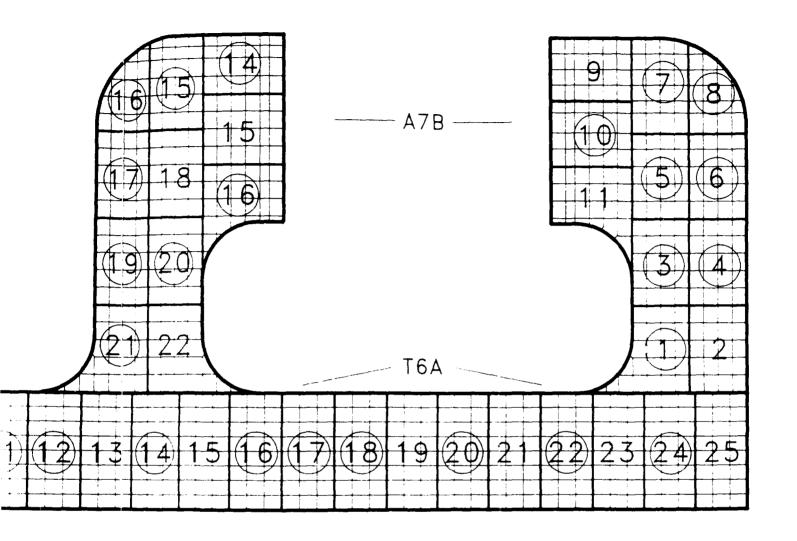
Figure 5. Sample unit layout, the hangar access taxiway

the hangar access taxiway (feature T6A) and hangar apron (feature A7B)

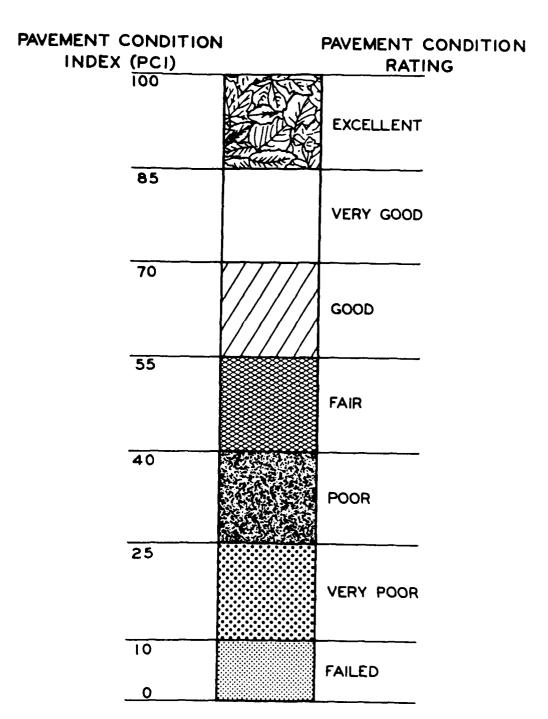
Figure 6. Scale for pavement condition ratings

- 11. The product of the condition survey is the PCI of the sample unit. The PCI is a value from 0 to 100 (worst to best, respectively) of the surface condition of the pavement. The PCI is obtained by determining a deduct value for the amount of each distress type and the severity found in the inspection, determining a corrected deduct value for the combined effect of various distresses on the pavement condition, and subtracting the corrected deduct value from 100. A pavement with no distress has a PCI of 100. Varying amounts of distress decrease the PCI value to a possible low of 0. Pavement condition ratings (excellent to failed) are assigned to different levels of PCI values; these ratings and their respective PCI value definitions are shown in Figure 6. The PCI of the pavement section is calculated by averaging the PCI's of the sample units surveyed.
